Technical Report REMR-CS-63
September 1999

Repair, Evaluation, Maintenance, and Rehabilitation Research Program

Repair and Rehabilitation of Dams: Case Studies

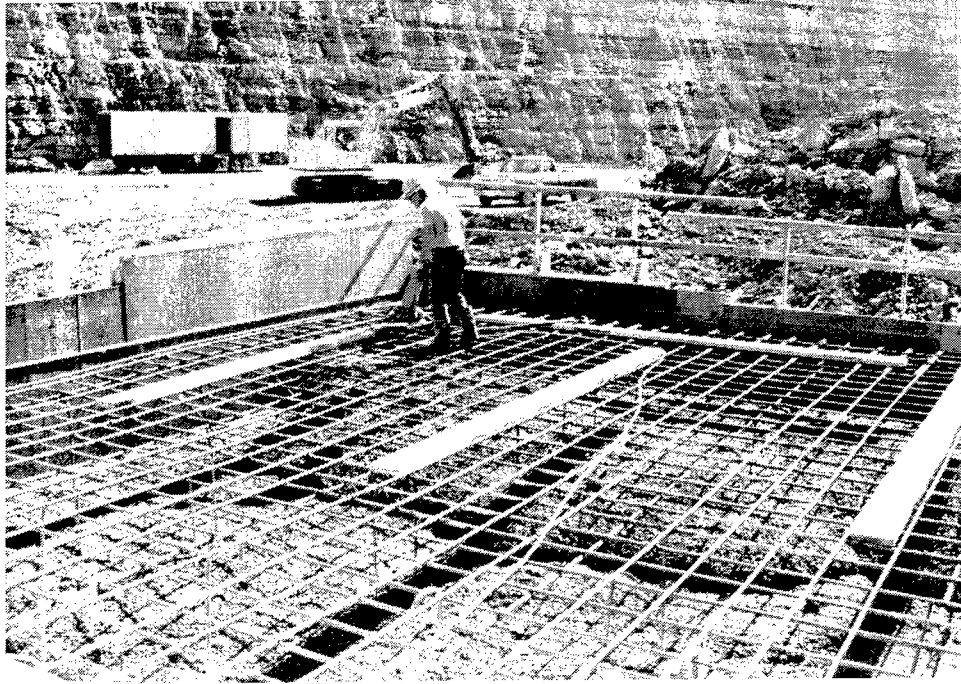
Figure 59. Forming and reinforcing for the top lift of concrete for the apron, Mowhak Dam (from U.S. Army Engineer District, Huntington 1990b)

An apron keyed into the rock was added to the existing weir cross section. Reinforcing bars anchored into the existing weir were used to secure the apron. Only the top lift of concrete for the apron was reinforced (Figure 59). The surfaces was screeded smooth (Figure 60).

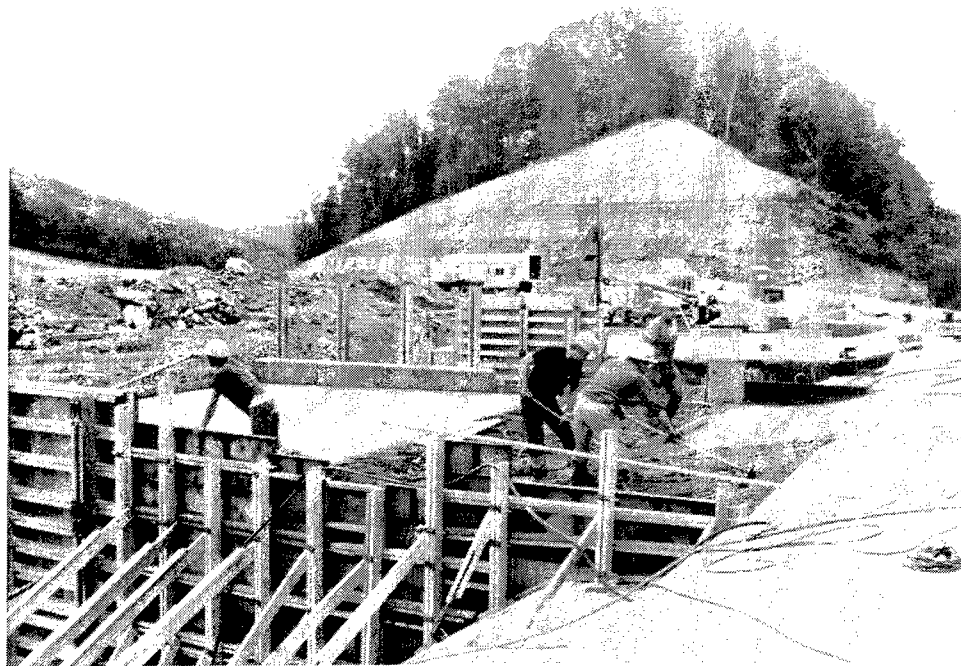
Figure 60. Placing and finishing concrete for the top of the spillway apron, Mohawk Dam (from U.S. Army Engineer District, Huntington 1990b)

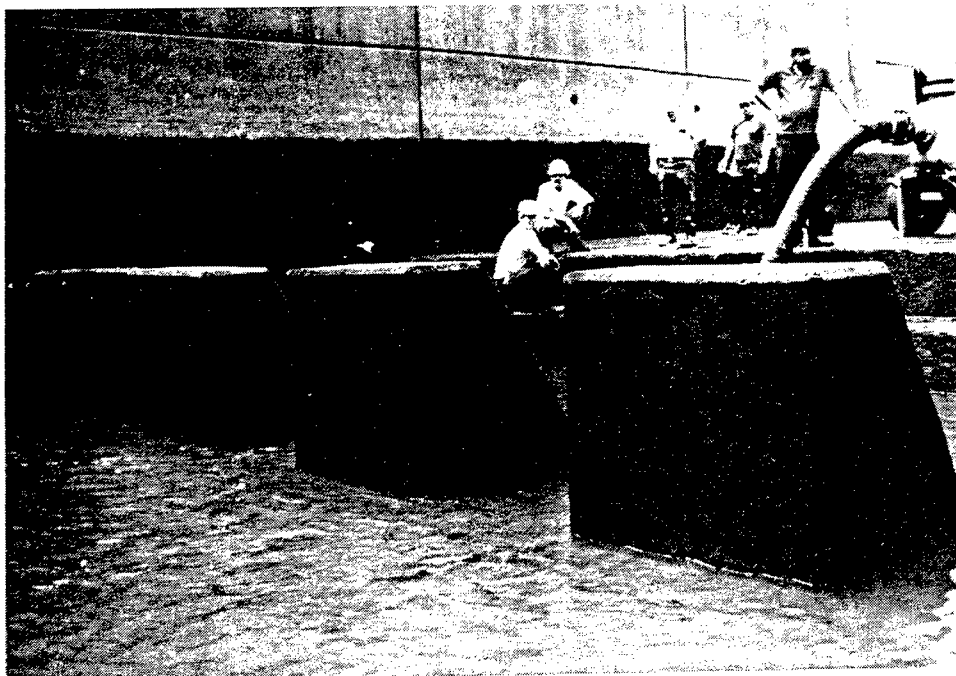
The stilling basin was dewatered in May 1977 during the final inspection of the outlet works. At that time, some damage to the baffles had occurred. During this inspection, erosional damage to both sides of the outlet channel was noted. No action was taken. The basin was again dewatered in 1980. Inspectors found no stones in the basin, but the damage to the baffles had worsened, and they noted an area of erosion downstream of the stilling basin. A study to determine the cause of the erosion and lack of stilling action in the basin was conducted. The conclusion was that the basin had been inadequately designed. To correct the design flaw, a concrete dam was constructed in the outlet channel to increase stilling action by raising the tailwater. The stilling baffles were rebuilt, and an anchored concrete slab was placed in the scour hole. A new 7.3-m- (24-ft-) wide bridge with walkway and parapet was placed on top of the new dam. The left side of the outlet channel was repaired with a semi-gravity, concrete hang-on wall, and stones were placed on both sides of the outlet channel to protect the slopes from erosion. Construction was completed in 1983. Dewatering and inspection in July 1993 revealed the general condition of the stilling basin to be very good. No chipping, spalling, or other damage was noted (Figure 61).

Figure 61. Upstream face and baffles in dewatered stilling basin, R. B. Bailey Dam (from U.S. Army Engineer District, Huntington 1993)

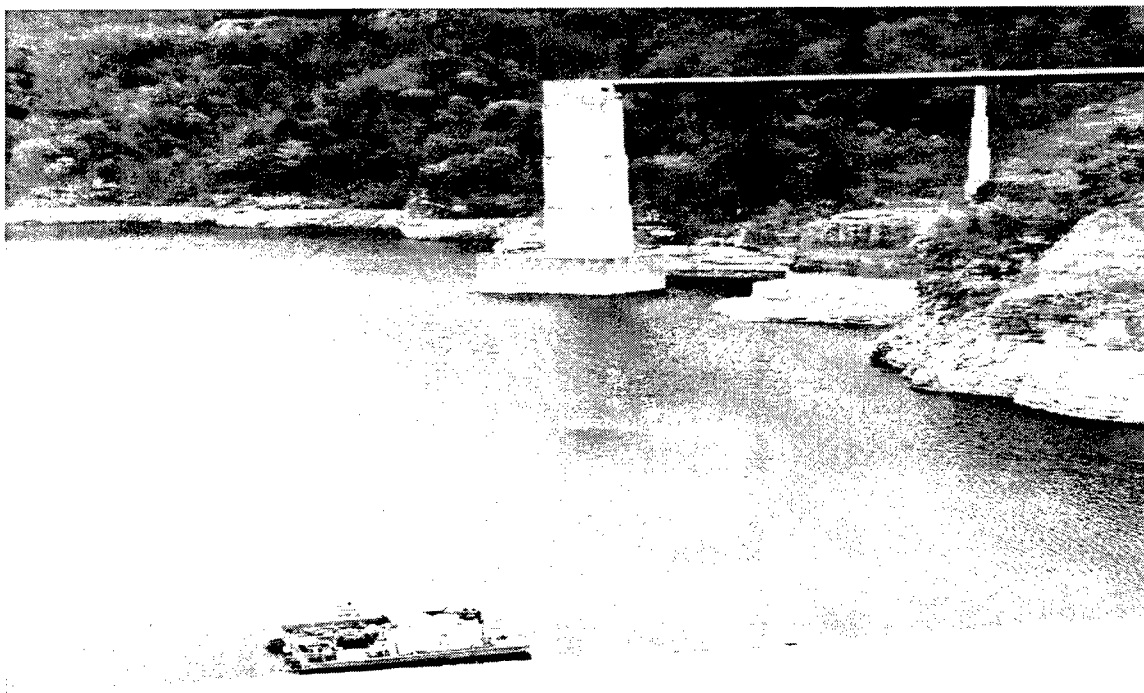
Moisture has been a problem in the intake structure since the dam became operable. During the first inspection in 1979, a number of cracks in the intake structure were noted in the walls and service platform. These cracks were not considered structurally harmful, but most did exhibit leakage when the pool was raised. Excess water (due to leakage) and high humidity levels caused problems with electrical equipment and created a safety hazard to those working with and around the equipment. Also, the excess moisture caused the paint on equipment to peel. In November 1984, a gutter was installed to channel seepage and condensation from the walls to the floor drain on the premise that if the gutter had solved or improved the problem, sealing the cracks would not have been necessary.

Figure 62. Intake structure and access bridge, R. D. Bailey Dam

In 1989, a plan to cover the outside of the intake structure (Figure 62) with an adhesive-mounted rubber membrane similar to roofing-type materials was considered. However, because of concern for loss of fish and other aquatic life and the impact upon recreational activities resulting from the proposed drawdown, a decision was made to make another attempt at sealing the cracks, this time from the inside.

In January 1990, plans and specifications for sealing the cracks from inside the intake structure were completed, and work was scheduled to begin in the spring of 1990. However, the specified materials were determined to be hazardous because of their low flashpoint. A recommendation was made that safer materials be used. Specifications were rewritten to use a polyurethane grout with a high flashpoint. The cracks were injected in 1991 with a single-component, moisture-reactive urethane liquid, which, upon curing, expands and forms a water-impermeable, elastomeric-polyurethane foam. The cracks injected ran vertically in a wall 4 m (3 ft) thick and then continued horizontally in a floor slab 2.4 m (8 ft) thick. The maximum external hydrostatic head on any crack

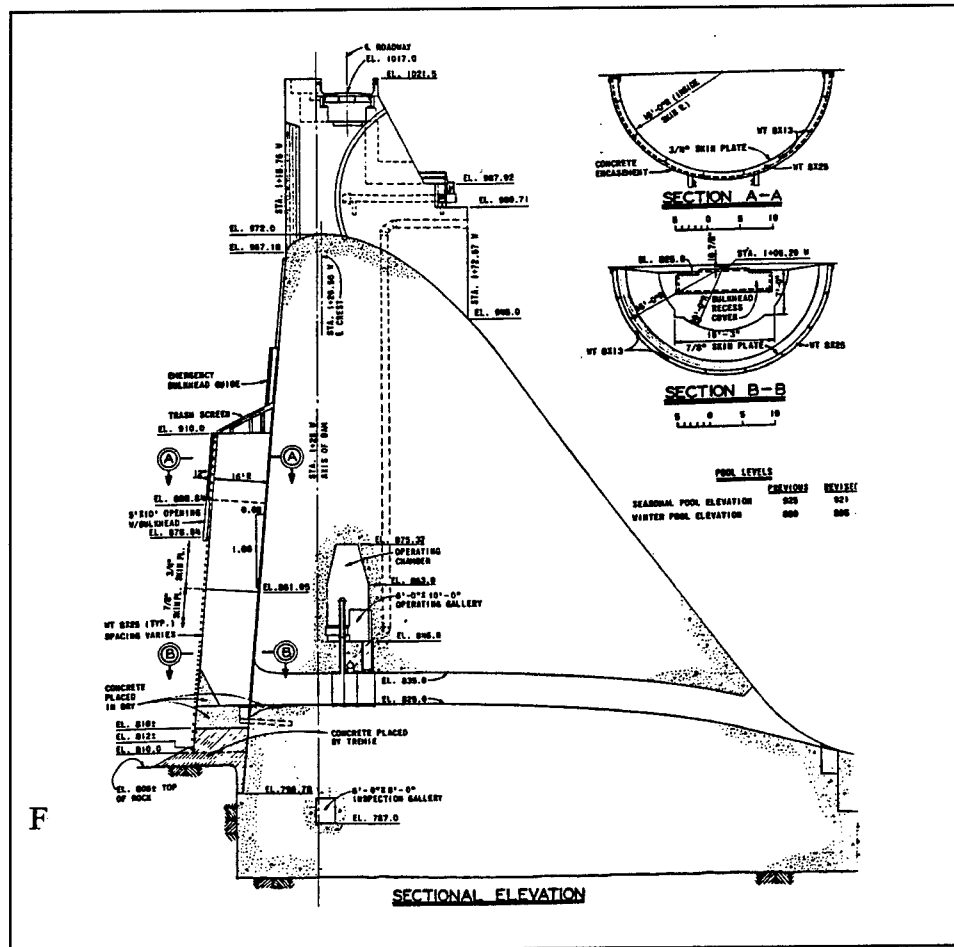
A 30.5-m- (100-ft-) high, 4.9-m- (16-ft-) radius, semicircular, high-level steel intake (Figure 64) was designed to be placed over the center sluice on the upstream face of the dam. Construction began in June 1979. The work had to be performed in winter, when the pool was near minimum. Even at low level, there was a high probability that a cofferdam would be overtopped frequently;

Figure 64. General design details of high-level intake at Sutton Dam (from Barnes 1982b)

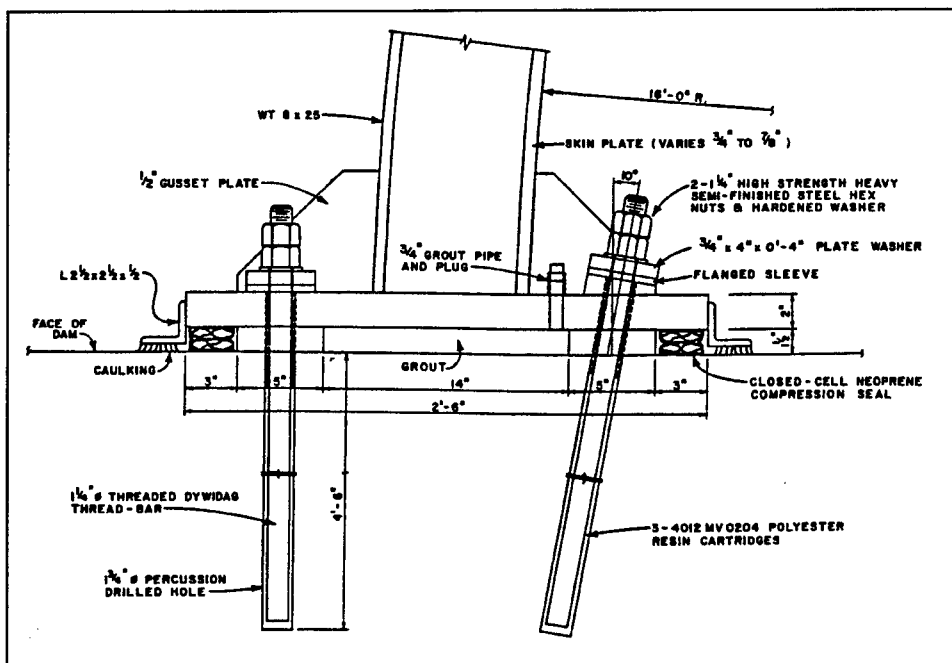
The foundation and bottom of the structure were formed of concrete, tremied into place. The 136-mg (150-ton) structure of plate-and-rib design was fabricated in three pieces and attached to the face of the dam with high-strength rock bolts (Figure 65). A circumferential concrete fillet was added at the invert in the bottom of the structure to improve flow conditions in accordance with model testing performed at WES. An inlet-with-bulkhead was installed below the top of the structure to permit the passage of water during low lake levels. Finally, the top of the structure was capped with concrete to a depth of 6 m (20 ft). The concrete cap would improve flow, provide support for the trashrack, and provide an aesthetically “finished” appearance (Barnes 1982b).

Figure 65. Connection detail for intake at Sutton Dam (from Barnes 1982b)

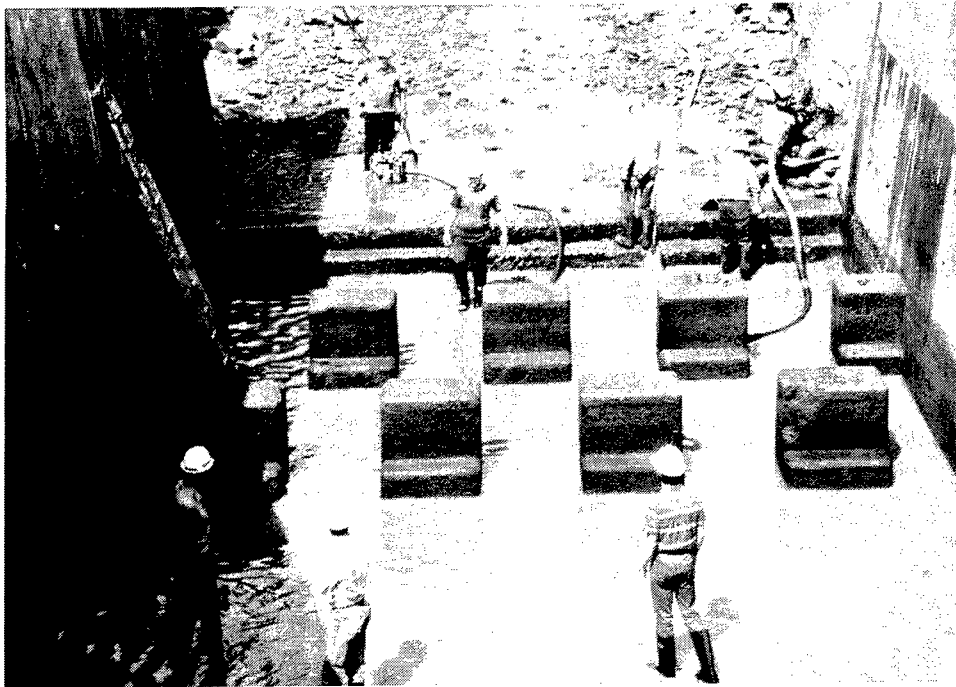
The stilling basin was dewatered for the Fifth Periodic Inspection (Figure 66). All components were in satisfactory condition. A depression from 25 to 51 mm (1 to 2 in.) was found in the center of the basin floor, but no remedial action was planned. Monolith joints in the training walls had slight damage, spalling, and popouts (Figure 67) but none that required repairing.

Figure 66. Stilling basin dewatered for fifth periodic inspection, Tom Jenkins Dam (from U.S. Army Engineer District, Huntington 1990c)

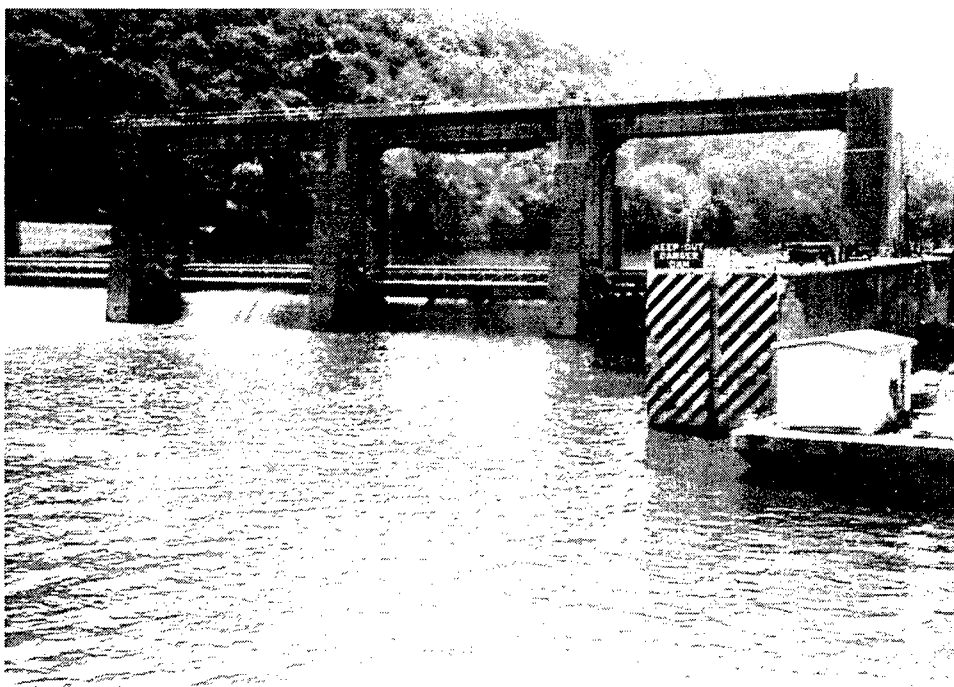
The Seventh Periodic Inspection (USAED, Pittsburgh 1994) found that the condition of the dam and appurtenances was good (Figure 72). Fine, random cracks in refaced areas below the upstream bridge bearings on Piers 5 and 7 have developed; these will be visually monitored by staff and will be sealed as time and funding are available. Corrosion on the top flange of the upstream bridge girder has caused cracking and spalling in the overlying concrete deck slab. The recommendation for these areas is to clean and reseal the expansion joints to eliminate leakage that is causing the corrosion.

Figure 72. Downstream face of Point Marion Dam; end of old land wall is at right (from U.S. Army Engineer District, Pittsburgh 1994)

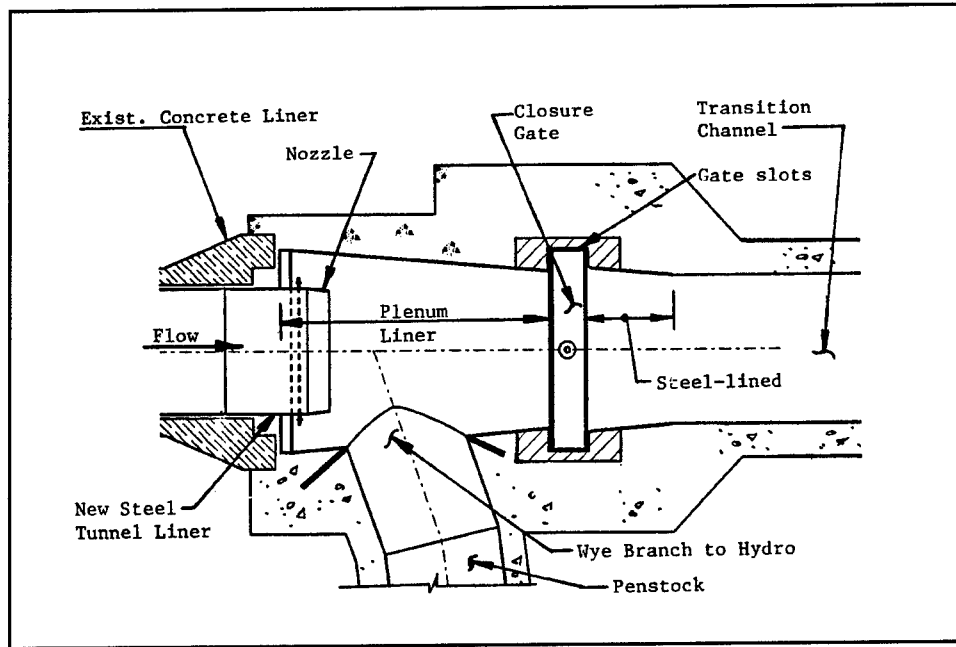
A plenum chamber was installed at the end of the downstream tunnel liner to convey water from the tunnel to the hydrofacility under the power generation mode and to supply a transition from the tunnel to the flip bucket during flood control (Figure 81). Hydraulic model studies of the plenum chamber configuration were conducted in late 1986 at Colorado State University to ensure the design would not create a shape of discharge from the flip-bucket structure significantly different from the discharge that would occur in the outlet works without the plenum chamber addition, would create no significant negative

Figure 81. Plenum chamber at Abiquiu Dam (from Kneitz 1991)

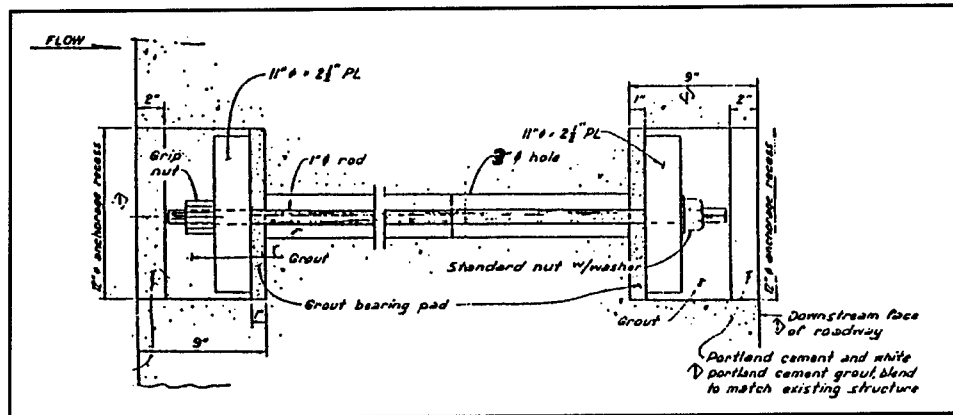
Figure 86. Steel rods used to reinforce cantilever portion of Norfolk Dam
(multiply inches by 25.4 to obtain millimetres)

In 1982, the concrete in the roadway on top of the nonoverflow monoliths was reinforced by retrofitting and posttensioning 25-mm- (1-in.-) diam steel rods on 1.8-m (6-ft) centers, transverse to the roadway cracks, in each of 38 monoliths (Figure 86). After installation of stress rods, 76-mm (3-in.) holes were drilled through the top of the dam monoliths and then grouted. The cantilevered portion of the dam roadway was reinforced with special strength 581-mm (2-in.) reinforcing bars. A 152-mm (6-in.) hole was drilled through the 12.2-m (40-ft) roadway of the dam; the reinforcing bar with a threaded end was inserted through the hole and tensioned with 550 MPa (80,000 psi). Nuts on the end of the reinforcing bar were tightened down on steel washers. The hole was grouted with high-strength grout, and the cavity for the nut and washer on each end of the reinforcing bar was concreted over. These reinforcing bars were placed every 6 m (20 ft). In 1983, the roadway cracks were sealed with a nonflexible epoxy. Cost of the repair was \$525,600.

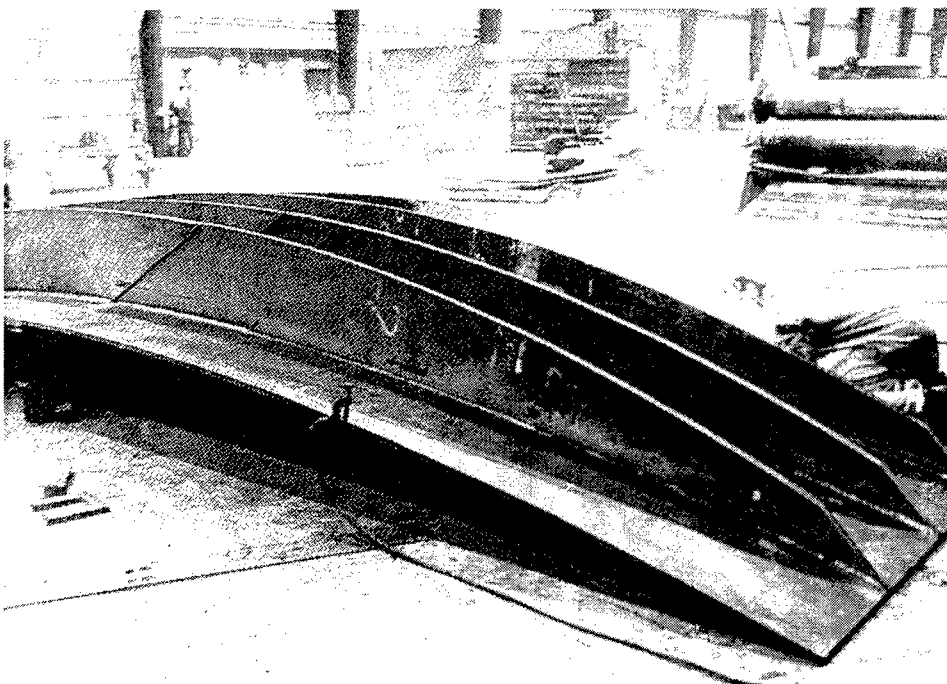
Alkali-aggregate reaction caused the expansion of the concrete at the outermost piers of the downstream face of the dam (Figure 90). The expansion caused binding of the drum gates, thus affecting operation of the dam.

Figure 91. Fabrication of Obermeyer Pneumatic Spillway Gates for installation
at Friant Dam (from *Hydro Power and Dam* 1997)

Following a 1992 study, the U.S. Bureau of Reclamation, owner of the dam, decided to replace the outer drum gates with rubber dams and rehabilitate the inner drum gate. Further studies were implemented. In 1997, BuRec decided to use the Obermeyer Pneumatic Spillway Gate System to replace the two outer drum gates. This system consists of high-strength steel gate panels connected to the spillway crest with a pivotal, reinforced elastomeric hinge. Inflatable actuators clamped along the hinge sections within an embedded keyway in the spillway concrete are used to operate the gates. This system provides a leak-proof connection.

The Obermeyer Pneumatic Spillway Gate System planned for installation at Friant Dam was being designed to match the curvature of the existing lowered drum gates (Figure 91). The project was scheduled to be completed in February 1998.

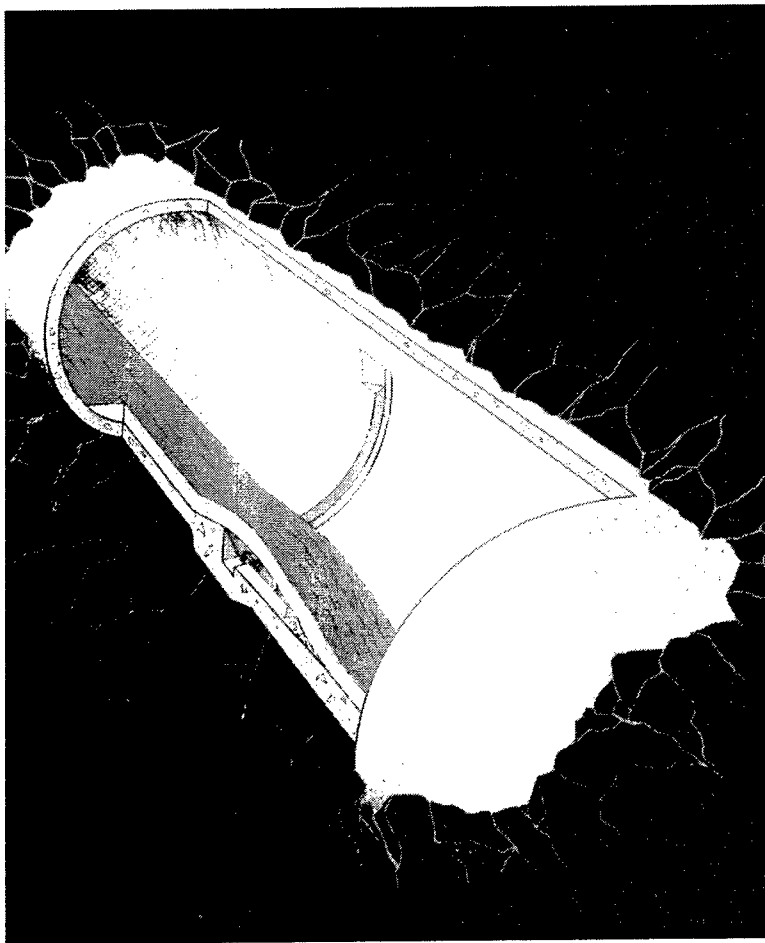
Figure 95. Aeration slot, Glen Canyon Dam (from Burgi and Eckley 1987)

The aeration-slot design for Glen Canyon Dam consists of a short length of ramp that lifts the flowing water over the air supply slot to prevent the slot from filling with water (Figure 95). The slot, which is 1.2 by 1.2 m (4 by 4 ft) in cross section, extends around the lower three-quarters of the tunnel. It is located on the 0.96 radians (55 deg) incline approximately 45.7 m (150 ft) above the start of the elbow and just below the 178-mm- (7-in.-) high ramp. The ramp is designed to create a low-pressure zone under the water jet which draws air into both sides of the slot from the tunnel above the water surface. The air drawn under the water jet is concentrated in the lower surface of the jet nappe and flows along the boundary through the elbow.

Construction of the aeration slots was made difficult by access restrictions, the wet work environment, and limited space. Concrete removal for the aeration slots was accomplished by saw cutting, drilling, and blasting. Installation of each slot required replacement of 8.8 lin m (29 lin ft) of the sloping tunnel liner. Approximately 535 cu m (700 cu yd) of concrete was placed per slot. The concrete was pumped into hoppers at the spillway bridge and gravity fed down a 76.2-m (250-ft) line to the placement area. Placement was made from downstream to upstream.

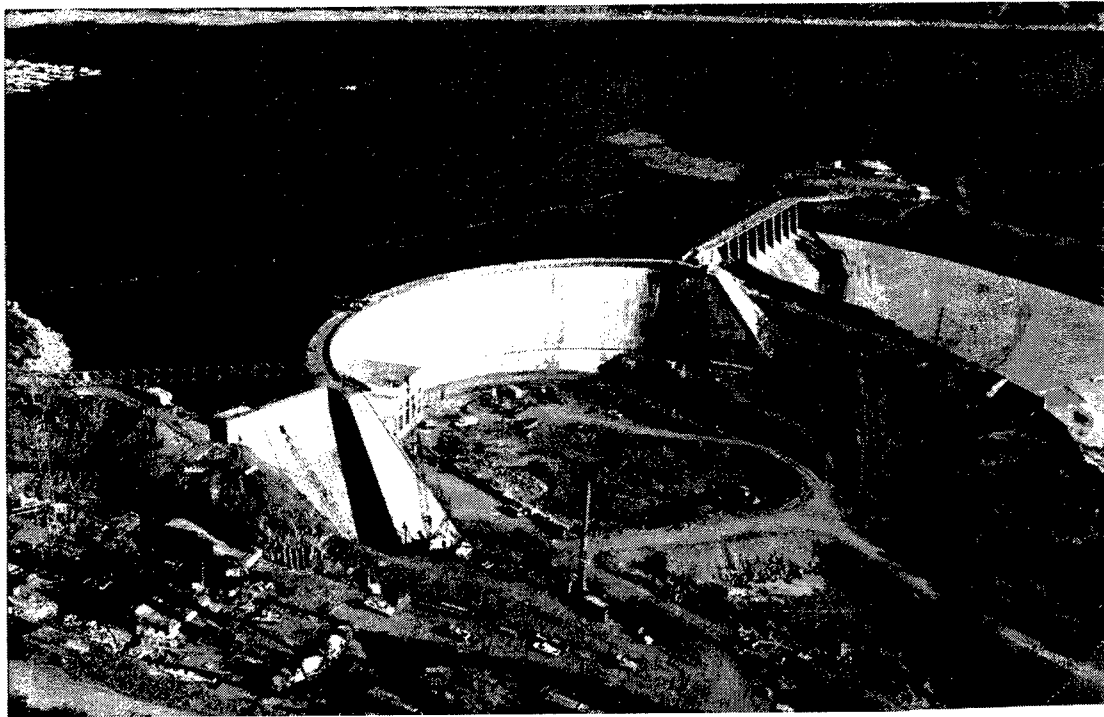
Structural stability investigations conducted by the BuRec in the late 1960s, indicated Stewart Mountain Dam was not stable enough to survive the revised maximum credible earthquake (MCE), Richter magnitude of 6.75 at 15 km (9.3 miles). The stability of the dam was questioned because of poor bond of the horizontal construction joints, deterioration of surface concrete, a 152-mm (6-in.) displacement of the arch crest, and revised PMF loads, which indicated the dam would be overtopped by 4.3 m (14 ft). The poor bond between the 1.5-m- (5-ft-) high concrete blocks of the dam was attributed to ineffective clean-up between placements during construction and the use of concrete with relatively high water content to combat high ambient temperatures at the time of construction. Alkali-silica reacted concrete caused the surface deterioration and the displacement of the arch crest. A three-dimensional finite element analysis of the dam under PME seismic loading conditions indicated there could be separation of lift joints which could cause failure of the dam (Nuss and Fielder 1988).

Figure 96. Overview of Stewart Mountain Dam (from Bruce, Fielder, and Triplett 1991)

After further study, BuRec decided to construct an auxiliary spillway to alleviate the PMF loading and to stabilize the dam against possible seismic loadings with posttensioned rock anchors. Posttensioned anchors had been used to stabilize concrete gravity dams, but this was believed to be the first time this method was used to stabilize a thin arch concrete dam (Nuss and Fielder 1988).

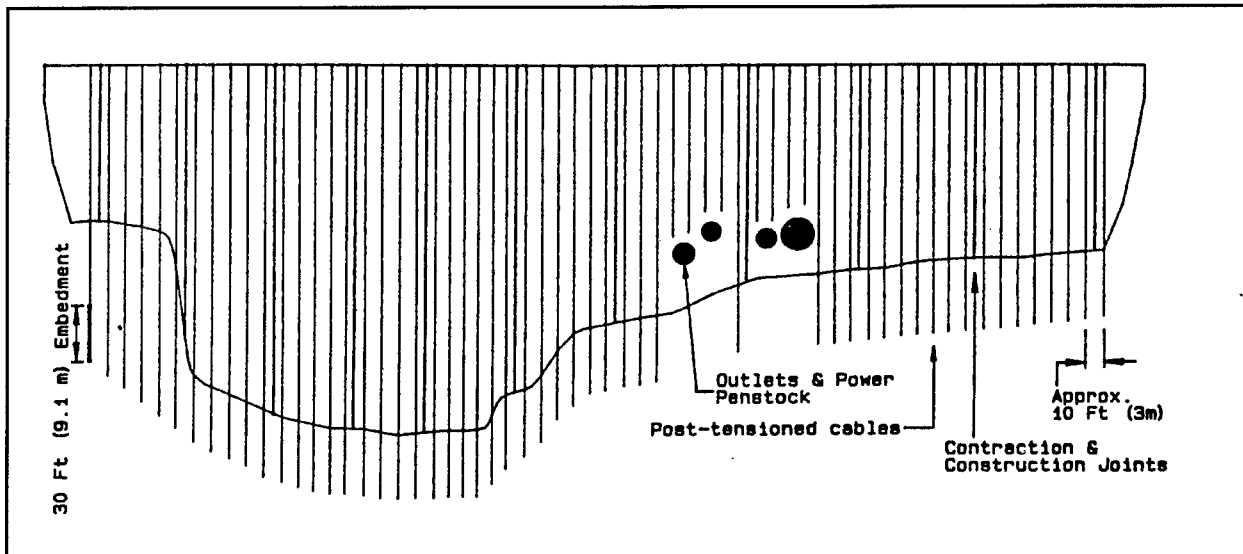
Figure 97. Profile Stewart Mountain Dam, showing locations of posttensioned tendons (from Nuss and Fielder 1988)

The installation of posttensioned cables was judged to be the least expensive, most viable solution for stabilizing the arch dam. Sixty-two tendons with free lengths ranging up to 65.8 m (216 ft) and bond lengths in the foundation from 9 to 13.7 m (30 to 45-ft) were installed on approximately 2.7-m (9-ft) centers (Figure 97). Each arched tendon was made up of 22 (152-mm- (0.6-in.-) diam)

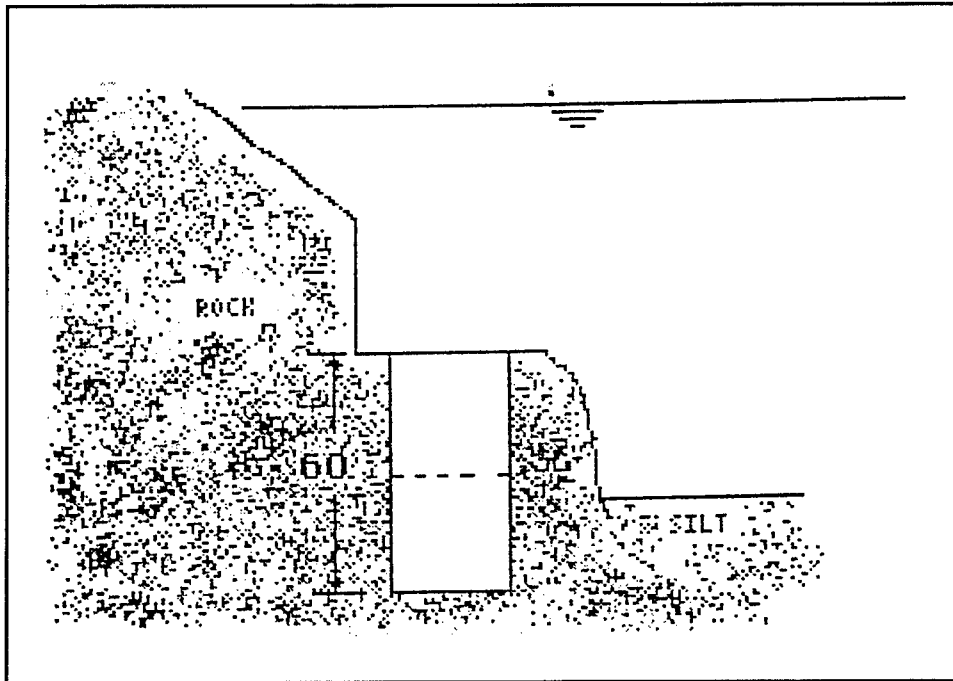
Figure 102. Inlet tube shaft at Theodore Roosevelt Dam

Once the bench was completed, the template was cut and reformed and used for the inlet tube shaft, which was excavated in a horseshoe shape to accommodate the 1.6-radian (90-deg) angle in the inlet tube (Figure 102). The steel inlet tube was floated out to the site and inserted in the completed shaft. The inlet tube was grouted into place with tremie concrete (Figure 103). Specifications for the tremie concrete called for a 27.6 MPa (4,000-psi) compressive strength. The mixture contained 25-mm (1-in.) aggregate and a plasticizer. The ROW tunnel is 200.6 m (658 ft) long with a 4.9-m (16-ft) finished diam. Reinforced concrete was used to line the section of the ROW upstream of the gate chamber, and the cross section downstream of the bifurcation structure is lined with steel and reinforced concrete. After the inlet tube was installed, capped with a bulkhead, and dewatered, the remainder of the ROW was mined along the pilot tunnel to the inlet and from the gate shaft to the outlet. Then the 108.2-m- (355-ft-) long, 3.8-m- (12.5-ft-) diam power penstock tunnel was constructed, the

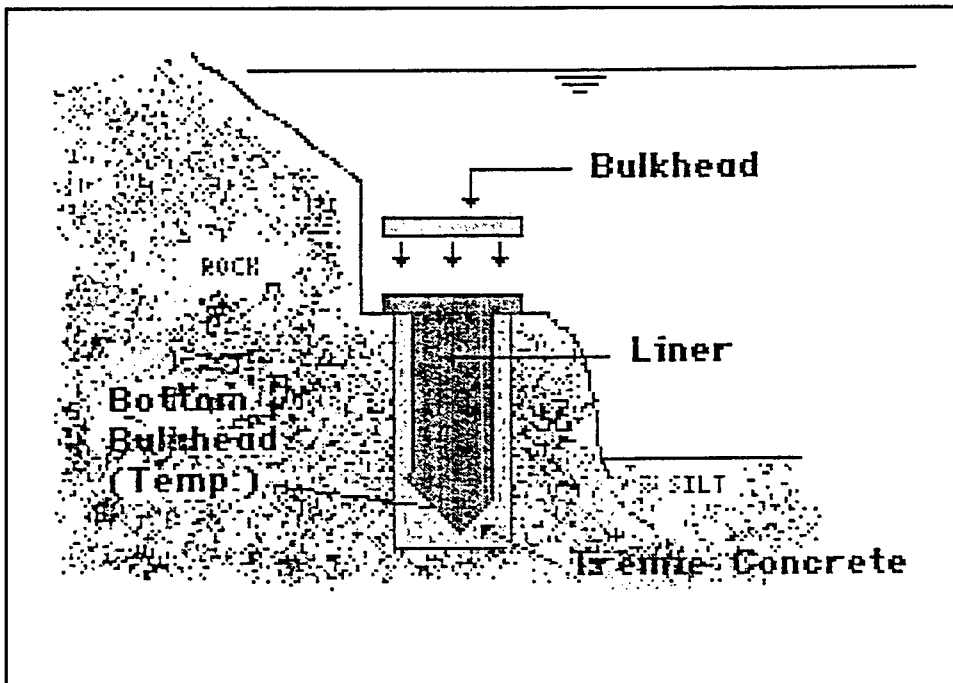
Figure 103. Inlet tub placement with tremie concrete at Theodore Roosevelt Dam

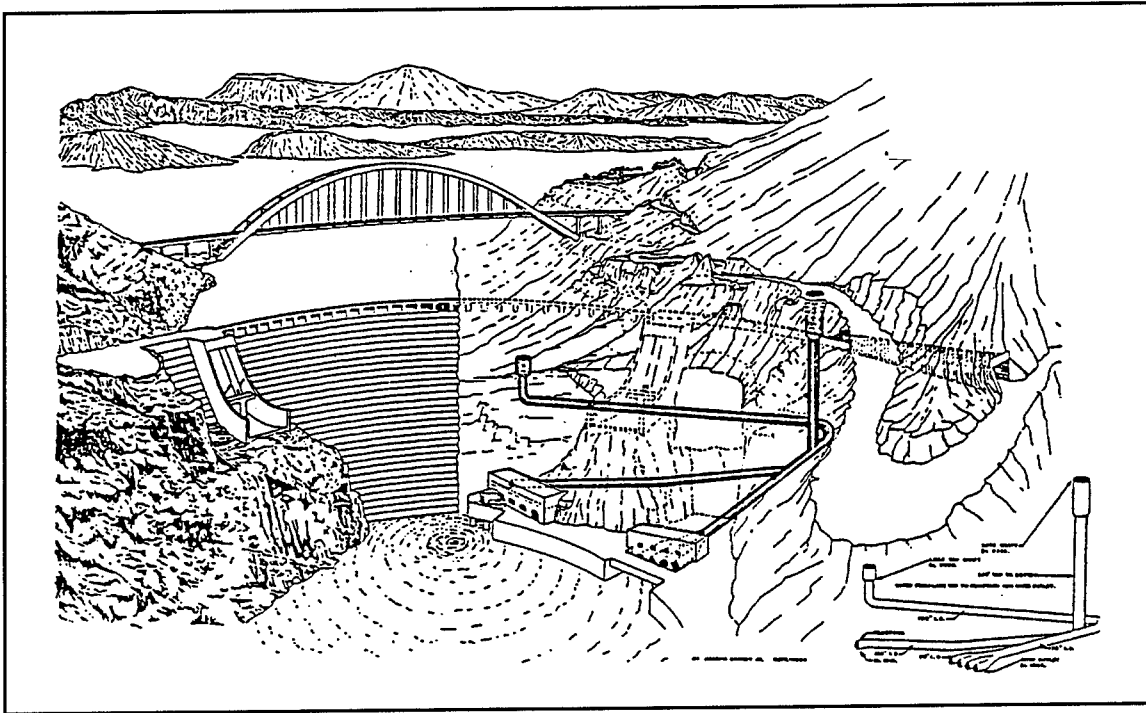
Figure 104. Penstock tunnel installed at Theodore Roosevelt Dam

gate was installed in the gate shaft, and alterations were made to the power plant (Figure 104). The original 49,500-horse-power (hp) turbine was replaced with a new, smaller turbine having the same capacity and capable of operating at the new higher reservoir heads (Beall 1991).

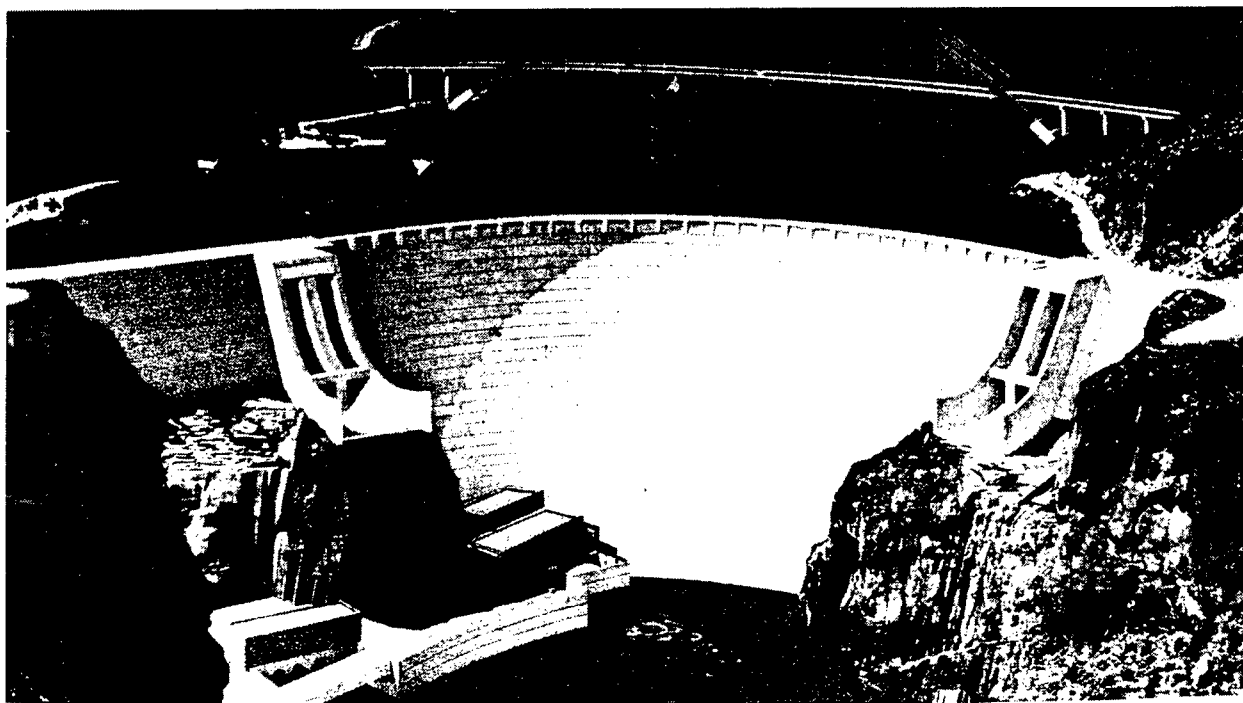
Figure 105. Modifications performed at Theodore Roosevelt Dam

Once the concrete overlay was installed, exposed concrete surfaces were cleaned and stained so they would more closely match the surrounding rock. Figure 105 provides an overall view of the modifications to the structure.

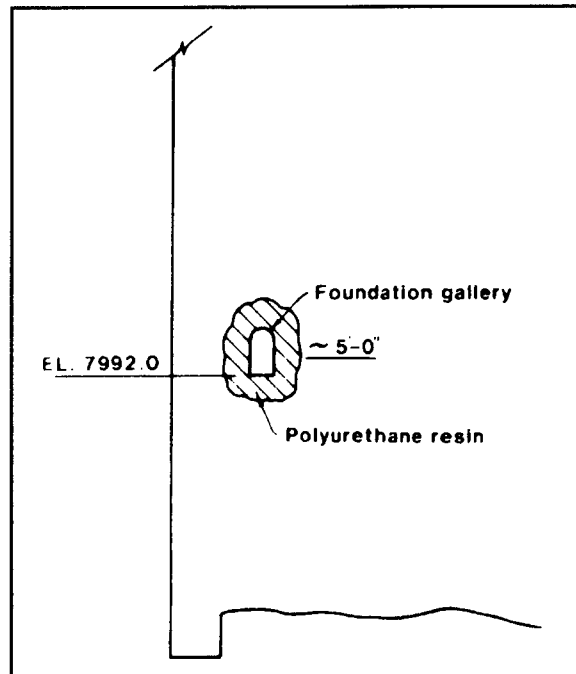
Figure 107. Plan for first injection stage at Upper Stillwater Dam (from Smoak 1991)

Because the reservoir level would change with the seasons, creating the potential for crack movement, a flexible hydrophilic polyurethane resin was selected as the repair material. Another characteristic of this material is that it allows for multiple injections. The injection was accomplished in three stages. Work for the first two stages was executed from the gallery and the downstream face at elevations below the reservoir water level. The first objective of the first stage was to cut off the flow of water into the gallery. A series of 16-mm (5/8-in.) holes were drilled from the gallery walls at an angle to intercept the crack at depths of 0.3 to 0.9 m (1 to 3 ft.) Injector valves ("wall spears") were placed in the holes and opened to relieve the water pressure in the crack. The surface of the crack between wall spears was then sealed with wood wedges, lead wool, or urethane-soaked jute rope or oakum. When the flow of water was controlled, a urethane resin pump system was connected to the injectors, and resin was pressure injected into the crack (Figure 107). If needed, the crack was reinjected.

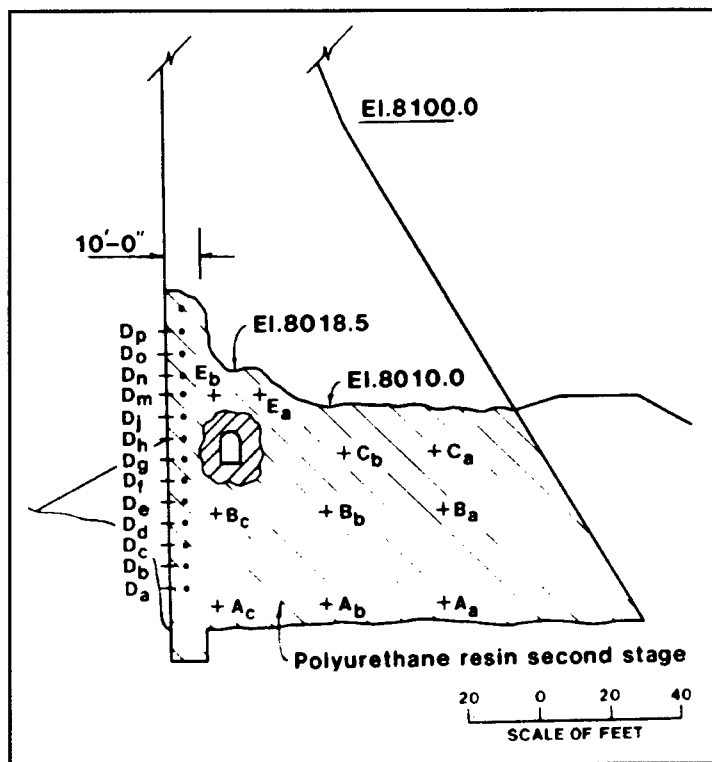
Figure 108. Injection plan for Stage 2 of Upper Stillwater Dam (from Smoak 1991)

The major work in the repair project was performed during the second stage. The first step was to drill 25-mm- (2-in.-) diam holes to intercept the crack at the locations shown in Figure 108. The holes varied in depth from 5.8 to 28 m (19 to 92 ft). When the drill hole intercepted the crack, as evidenced by the drill water loss, a pneumatic packer was set several feet from the hole-crack intercept, and the hole was injected with resin. The D-line of holes was drilled and injected first to reduce water flow during drilling and injection of interior holes. The alphabetical designation of the holes

indicates the sequence of drilling and injection. Water-to-resin ratios varied from 0:1 (neat resin) to 2:1 with most injections done at a 1:1 ratio. Check holes were used to determine whether the crack had been sealed; if not, additional holes were drilled and injected until the crack was adequately sealed.

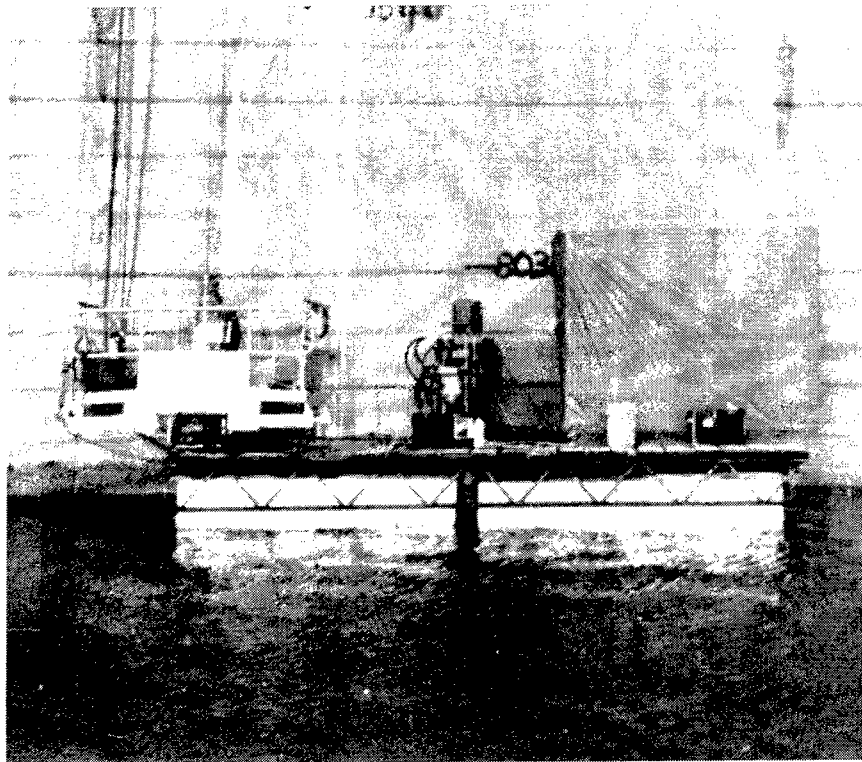
Figure 109. Work platform used at Upper Stillwater Dam (from Smoak 1991)

The third stage of the injection involved sealing the crack on the upstream face of the dam above the drawn-down water level. A floating barge and a spider platform suspended from the top of the dam were used as work platforms during the drilling and injection procedures (Figure 109). Crack intercept holes were drilled 305 to 610 mm (12 to 24 in.) apart on alternate sides of the crack and angled so they would intercept the crack about 0.6 m (2 ft) from the upstream face. Wall spears were installed and then the holes were pressure injected with resin. Workers started at the lowest injection hole and moved up the crack to the top of the dam. Resin volumes were calculated to permit injection of a zone approximately 3 m (10 ft) into the dam; however, in some instances, miscalculations resulted in the resin penetrating the entire section and coming out on the downstream face. A 1:1 water-to-resin ratio was used for the crack at these elevations. Check holes were used to determine whether the crack was sealed.

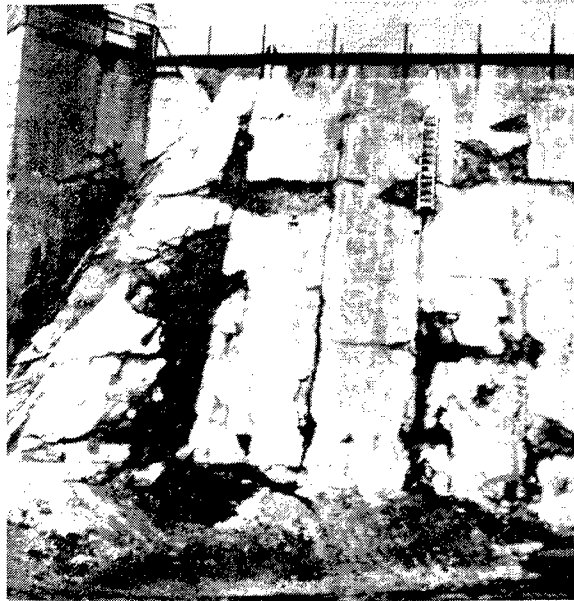
Since its construction, Big Eddy Dam has suffered severe visible deterioration of the concrete and has experienced extensive seepage of water throughout the dam. A variety of repair methods was tried; all failed to halt the concrete deterioration and the seepage. The failure of a shotcrete repair of the downstream face is shown in Figure 114.

In 1974, International Nickel Company, owner of the dam, initiated an investigation to determine the cause of the major problems at the dam. A visual inspection and testing of cores taken from the east wing wall were accomplished. The main causes of deterioration were identified as cycles of freezing and thawing and alkali-aggregate reaction. Further investigation in 1975 indicated a need for a comprehensive study of the dam. Gore and Bickley (1987) reported the investigation and subsequent remedial steps taken. This case history is a summary of their report.

Figure 114. Deteriorated shotcrete repair on the downstream face of Big Eddy Dam (from Gore and Bickley 1987)

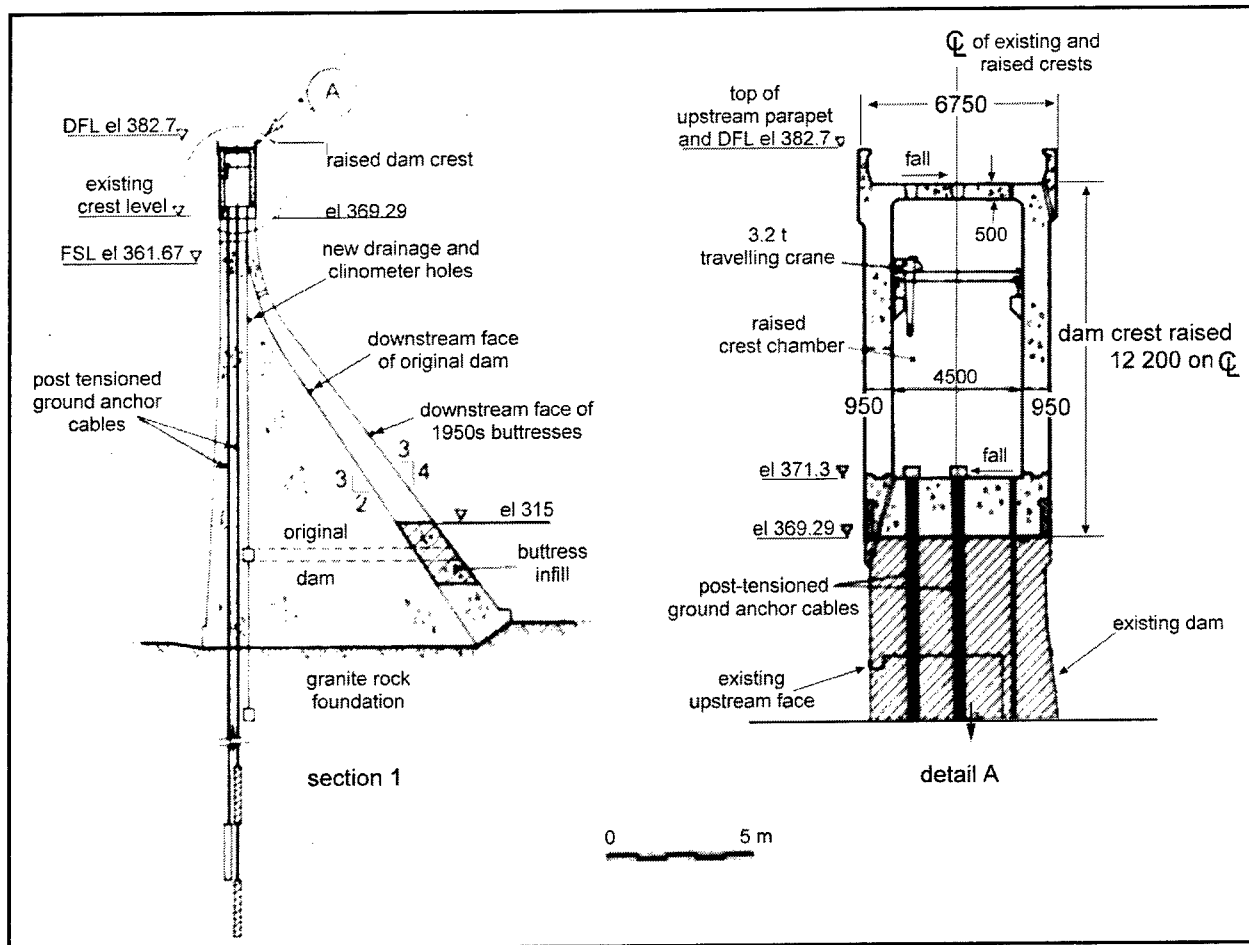
In 1990, work began on a project to increase the height of the dam by 12.2 m (40 ft). An open reinforced-concrete chamber was constructed at the existing crest level of the dam, and the dam was stabilized with posttensioned ground anchor cables (Figure 118). During high flood levels, the chamber fills with water, thus providing additional stability. Two rows of posttensioned ground anchors provide a stabilizing force of 14,200 kN/m (5,240 tons/ft) for the dam. The anchor cables, each consisting of 63 strands (15.2-mm- (0.6-in-) diam) were placed on 1.5-m (5-ft) centers. To provide corrosion protection, strands were encapsulated in grease-filled polyethylene tubes above the anchorage zone, and cables in the anchorage zone and the free length of cable were installed in a single-stage grouting operation. Type G oil well cement was specified for the grout; it produced a high-strength, low-shrinkage, and low-bleed mixture. Cable load is monitored, and the anchors can be restressed if necessary.

Figure 118. Section through Burrinjuck Dam, showing details of raising height of dam 12.2 m (40 ft)

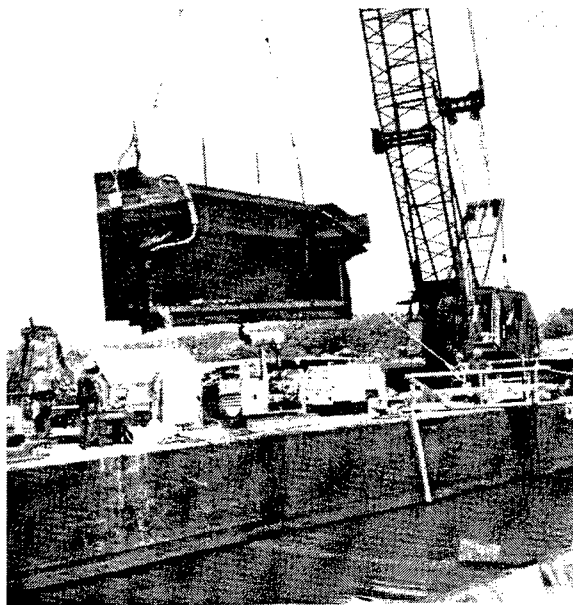
Structural repairs made to the dam faces followed two underwater inspections: the first inspection gave a basis for bidding while the second (an underwater video inspection) aided the contractor in identifying specific areas to be dewatered and repaired. Portable cofferdams were fabricated and assembled onsite to dewater repair areas. On the upstream side of the dam, all repairs were within 1.5 m (5 ft) from the crest. The 1.2-m-wide by 1.7-m-deep (4-ft-wide by 5-1/2-ft-) deep by 90-m- (30-ft-) long cofferdams used in this area were fabricated to match dam contours (Figure 120). Cofferdams used to dewater the downstream toe and apron sections were 7.6 m (25 ft) wide by 4.3 m (14 ft) deep by 9 m (30 ft) long.

Figure 120. Portable cofferdam used upstream at Crescent Dams (from Sumner, Nash, and Haag 1991)

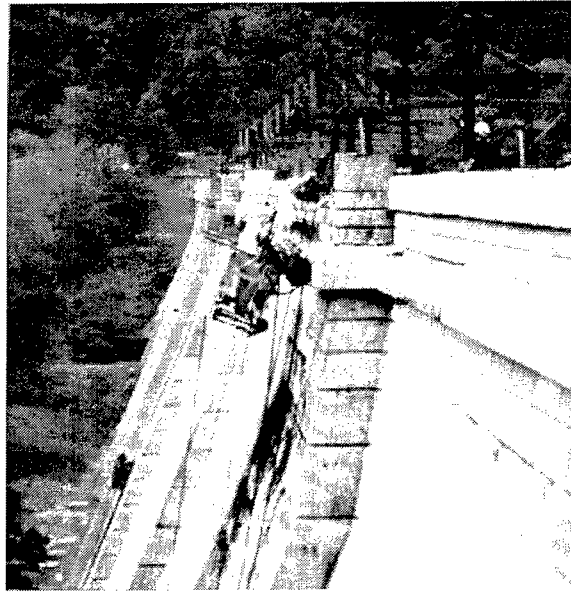
Figure 126. Power-operated cradles used for making repairs to downstream face of Haweswater Dam (from Fosroc Focus 1990)

render layer of Renderoc, but the FC version was developed prior to full repair and was tested and approved in 1987. Joints between the repaired blocks were sealed with polyurethane sealant during the trial; this practice was carried over to the repair effort.) Work was performed from power-operated cradles (Figure 126). Repair areas were first cleaned with air chisels, high-pressure water jets between 27.6 and 41.4 MPa (4,000 and 6,000 psi), and sand blasting. These methods enabled workers to remove spalling to depths of 100 mm (4 in.). The repair-mortar was mixed with water in a forced-action mixer and applied by hand to the entire downstream face on one side of the spillway. The fairing coat was then applied to areas that did not need repair so they would be receptive to the overall sealing coats. The silane-impregnated primer was applied with a low-pressure back pack spray unit that floods the surface to ensure full absorption, and then a methacrylate top coat was applied with a high-pressure spray unit. In addition, all joints not sealed during original construction will be sealed with a polyurethane sealant.
